# **A Damage Resistance Comparison of Wet-Wound IM7 and T1100 Carbon Fiber/Epoxy Cylinders**

*A.T. Nettles and A.M. Clark  
Marshall Space Flight Center, Huntsville, Alabama*

### A DAMAGE RESISTANCE COMPARISON OF WET-WOUND IM7 AND T1100 CARBON FIBER/EPOXY CYLINDERS

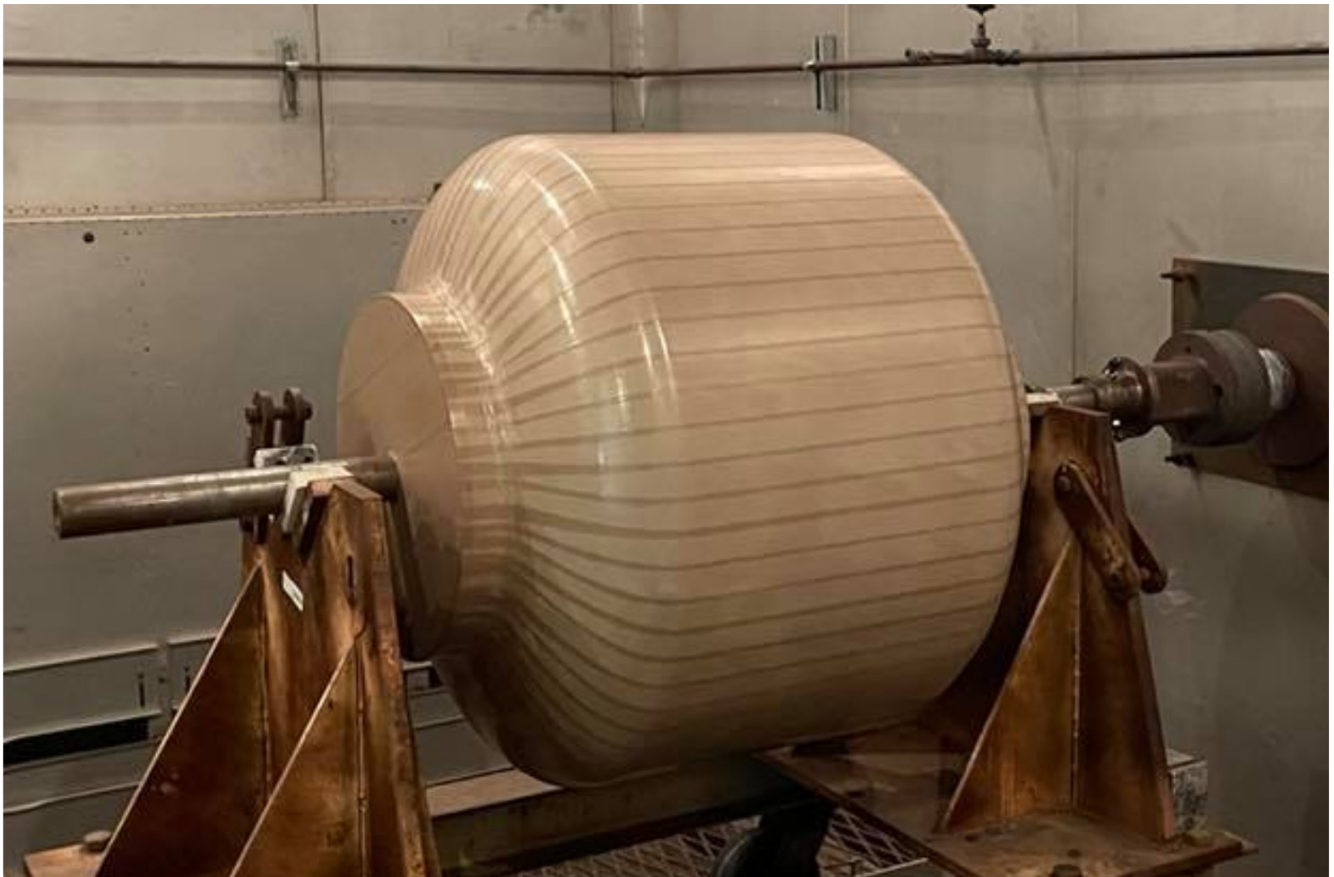
The mandrel was made of sand and a binder material from Advanced Ceramics Manufacturing. This mixture creates a hard solid that is machinable. The case dimensions were applied to the mixture and bonded to a 2.5-in-diameter steel shaft. The sand/binder mix is water soluble, so after the part is made and cured, the mandrel can be removed with water to leave the part behind. A picture of the sand mandrel is shown in figure 2.

Figure 2. One of the two sand mandrels used to manufacture the cylinders used in this study.

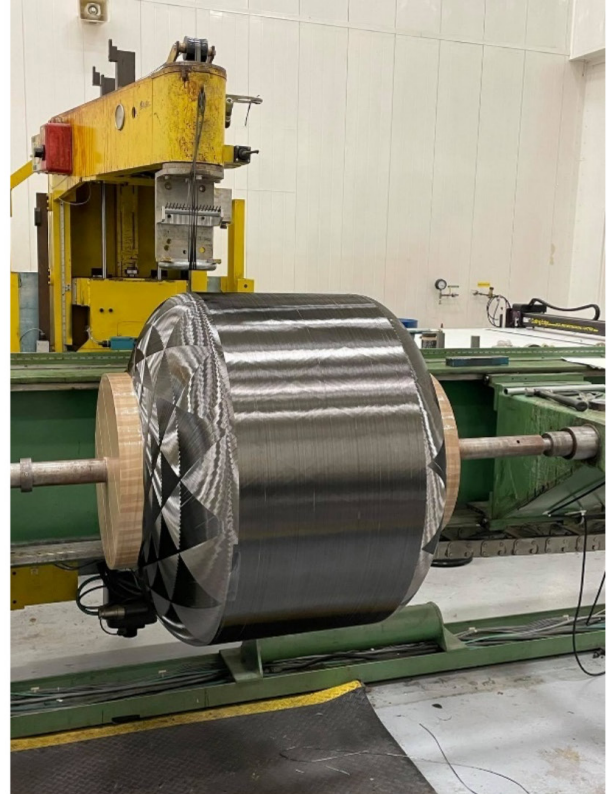
A dry wind (i.e., winding without resin), which is usually done to confirm the pattern of the fiber on the mandrel before resin is added, was performed for this project. Pictures of the helical-ply dry wind and the hoop-ply dry wind are shown in figure 3. Once the dry wind was completed and the winding pattern verified, the dry fiber was stripped from the mandrel before the wet-winding process began.

Figure 3. Dry winding to test filament winder settings before the actual wet winding is performed. Helical pattern is shown on left and hoop pattern is shown on right.

The helical patterns followed a  $\pm 33^\circ$  angle with a  $\pm 2^\circ$  tolerance while the hoops followed a  $\pm 88^\circ$  angle with a  $\pm 2^\circ$  tolerance.

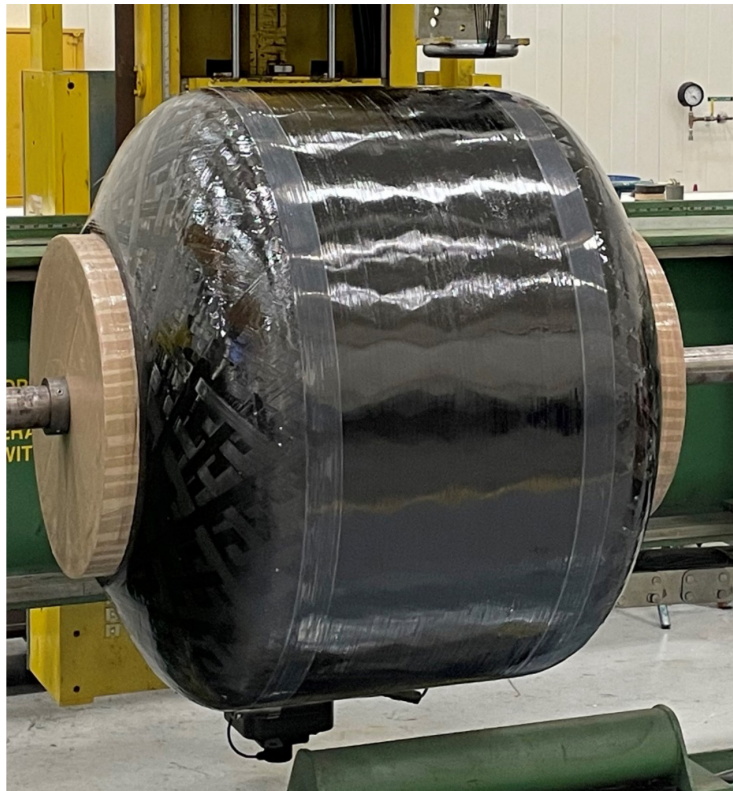
The first 8 layers were wound using the parameters detailed in Table 2. However, the mandrel was discovered to be broken after layer 8. A relatively quick fix was done to get one more layer onto the mandrel. To not lose the part completely, the cure cycle was started after layer 9, a hoop layer, was wound. Figure 4 shows the IM7 case after layer 9 and before the peel ply was added.

Figure 4. Wet-wound IM7 fiber cylinder after addition of ninth layer.
